LAMS-2293

NUCLEAR-CRITICAL ACCIDENT AT THE LOS ALAMOS
SCIENTIFIC LABORATORY ON DECEMBER 30, 1958

REPORT WRITTEN: February 1959

H. C. Paxton
R. D. Baker
W. J. Maraman
Roy Reider

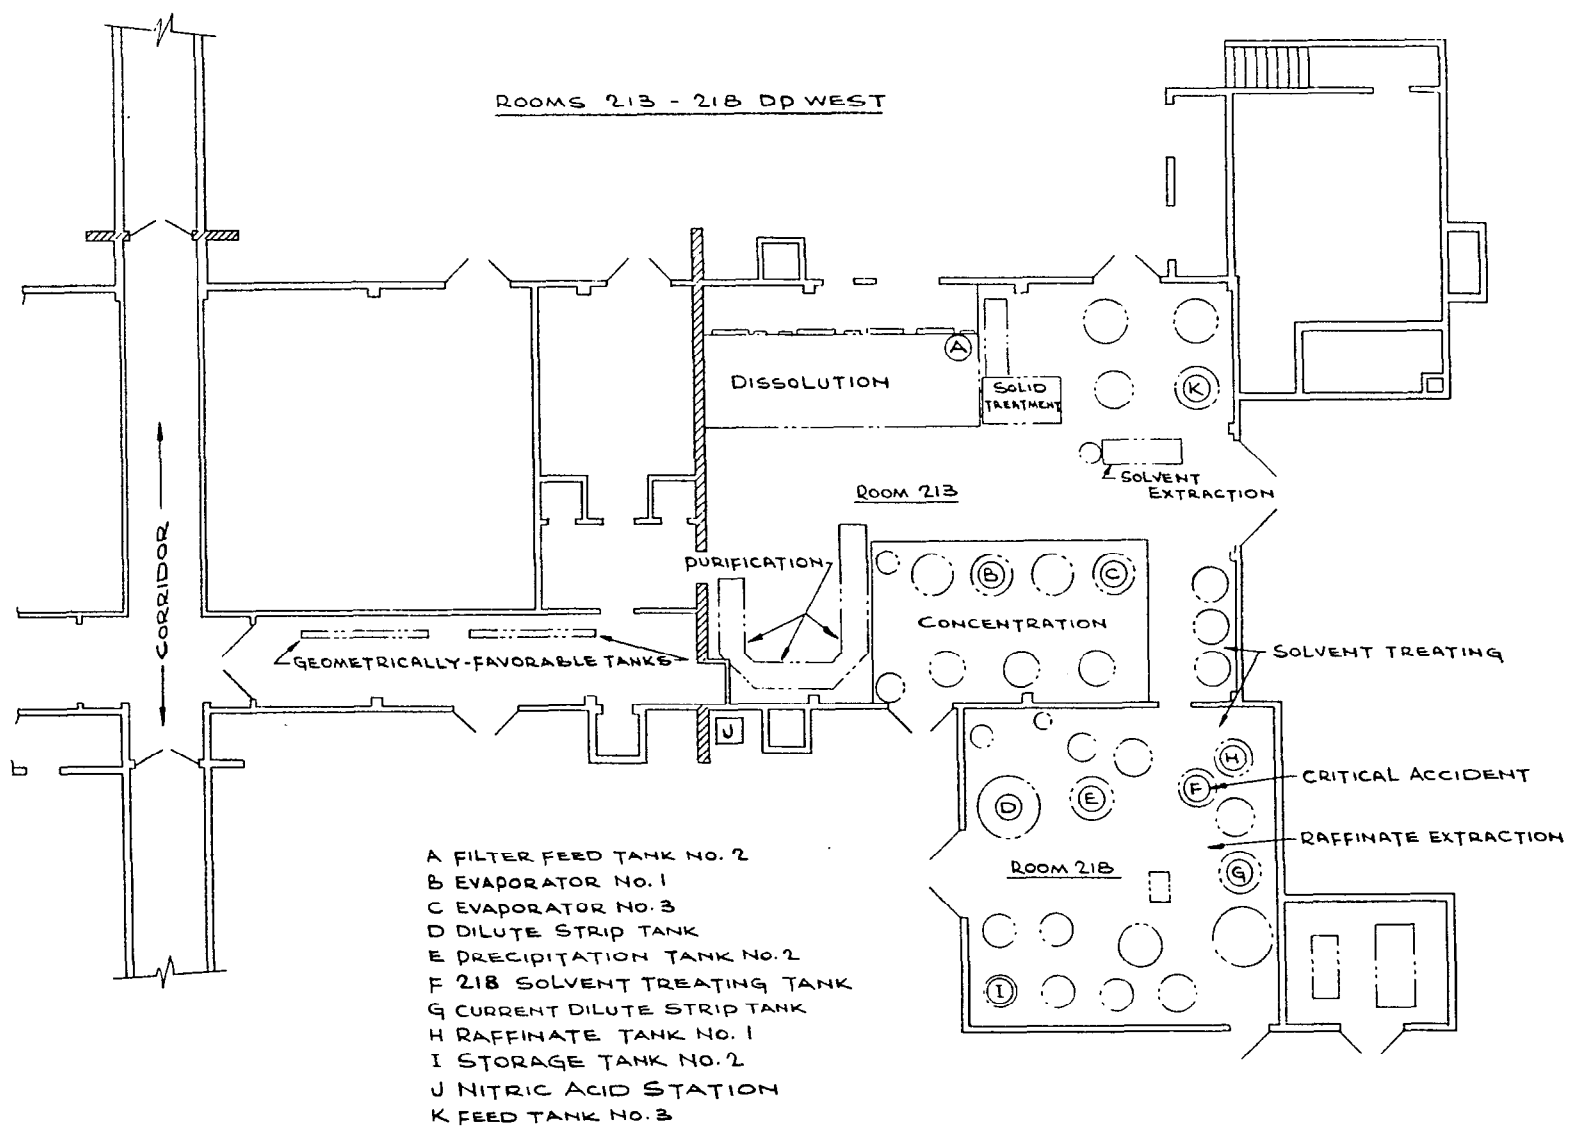
Fig. 3 Layout of equipment in area where accident occurred.

Material transfers leading up to the accident were as follows (refer to Fig. 3 for container locations).

1. Dilute Strip Tank: Fifty gallons of water had been previously added and agitated to attempt to dissolve an estimated 20 lb of solids in the bottom of this tank. This slurry was transferred into the Current Dilute Strip Tank, and the remaining solids were flushed into that tank with a 15-gallon stream of water.

2. Evaporator No. 1: Out of a 110-gallon batch of concentrated dilute strip and peroxide filtrate, 100 gallons was transferred to Filter Feed Tank No. 2 for filtration. (This is the capacity of the tank.) The remaining 10

3. Current Dilute Strip Tank: In addition to the above solutions this tank contained an estimated 320 gallons of dilute strip, 100 gallons of acidified caustic from solvent treating, 15 gallons of solvent residual from phase separation of dilute strip, and 2 gallons of a special recovery solution containing 4 g of Pu.

4. 218 Solvent Treating Tank: A 145-gallon batch of treated solvent containing 2.9 g of Pu was transferred from this tank into Raffinate Tank No. 1.

5. Storage Tank No. 2: This tank contained an 80-gallon batch of an emulsion resulting from the second treatment of a batch of solvent. This material was transferred into the 218 Solvent Treating Tank.

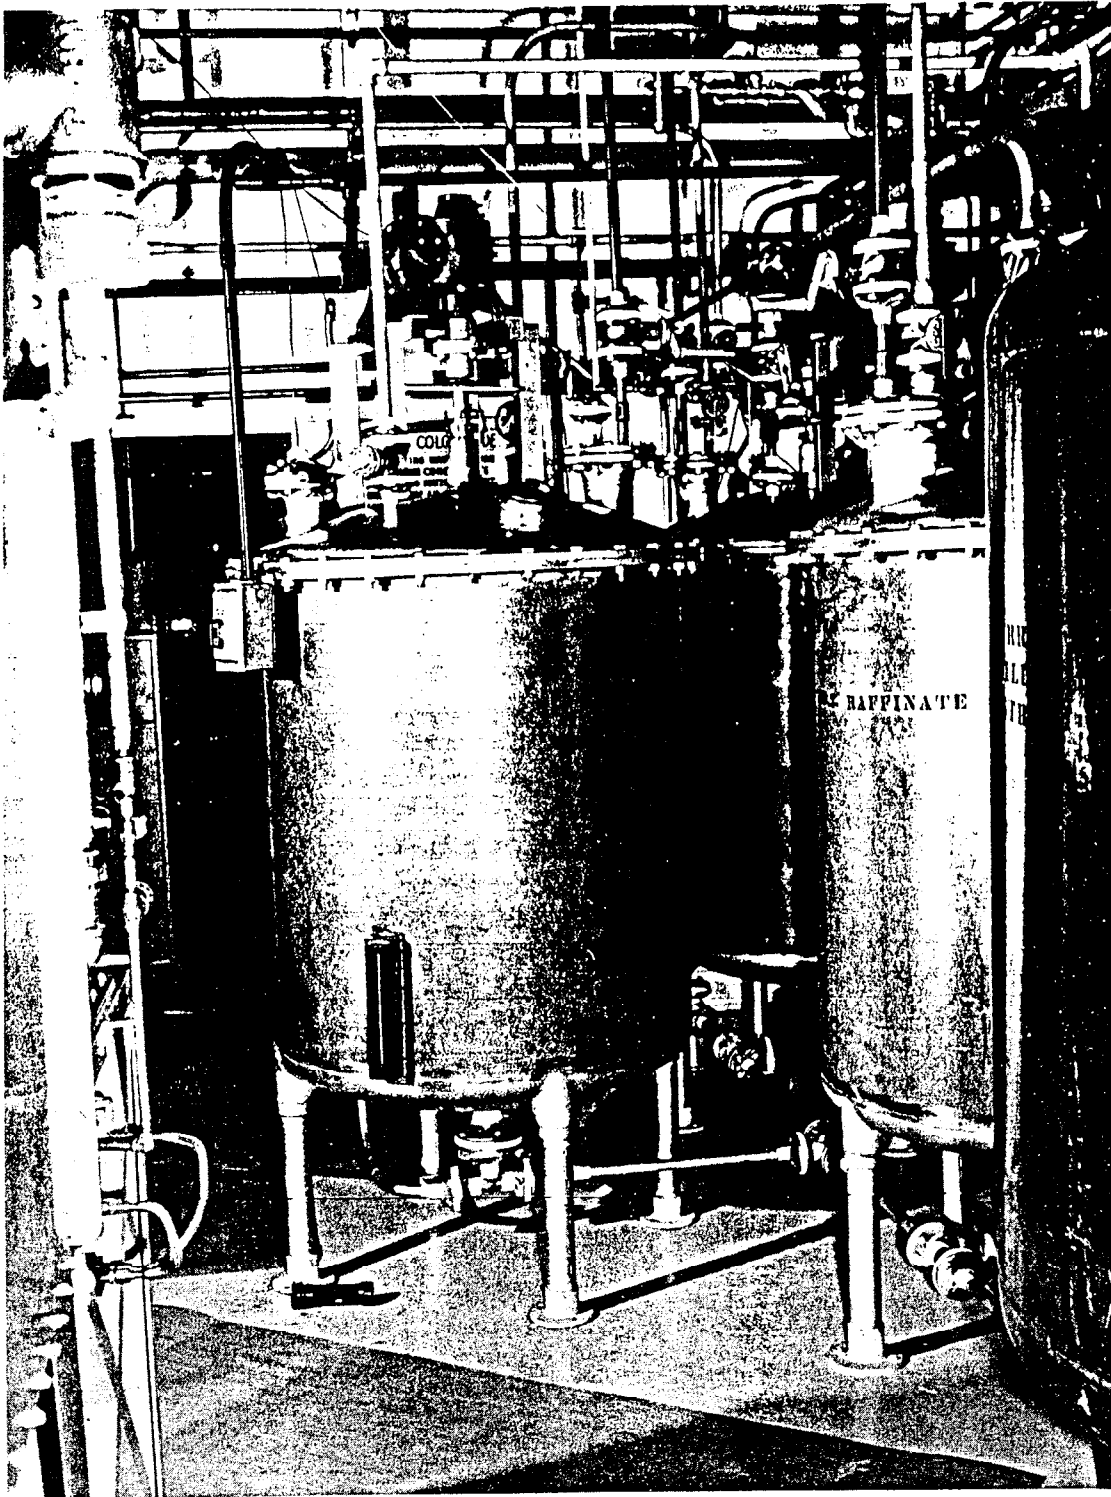
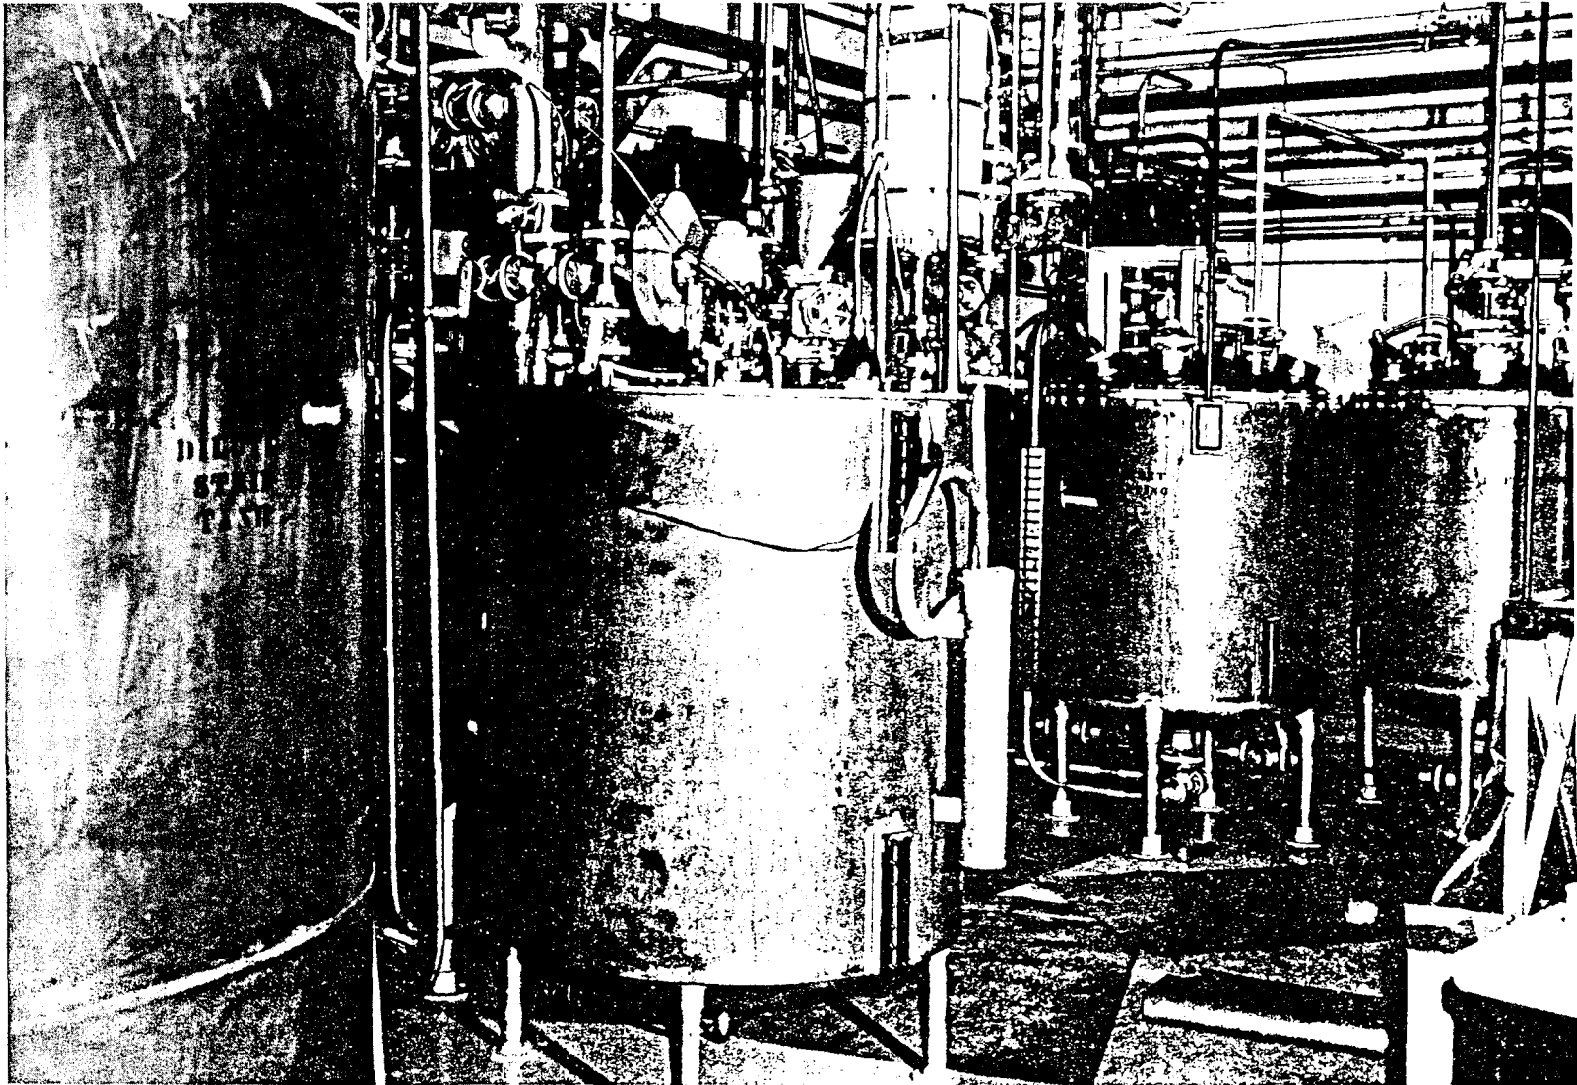
Fig. 10 218 Solvent Treating Tank.

solvent layer on top of the solution. Subsequent transfer of this plutonium-rich solvent and the nitric acid slurry of residual solids in the bottom of the tank into the 218 Solvent Treating Tank (Figs. 10, 11, and 12) acidified the emulsion, freeing additional solvent for further extraction of any remaining hydrolysis products into the combined organic phase. As in the case of the Current Dilute Strip Tank, mixing and extraction resulted from the air-sparging of this material through the bottom inlet of this tank. Upon cessation of the air-sparging the solvent phase separated into an 8-in. layer on top of the aqueous which was subcritical at this time. This thickness was determined by evaluation of the solutions in the tank after the accident. Phase separation took about 2-1/2 minutes.

A chemical operator started the motor driving the mechanical agitator in the solvent-treating tank. There was a "blue flash" and a muffled report. The operator, who was looking into a sight glass at the top of the tank (Figs. 10 and 12), was knocked off the two-step ladder on which he stood. Though the shock displaced the tank about 3/8 inch at its supports, the tank was not ruptured and no plutonium escaped. The operator apparently turned the stirrer motor off, then on again (this time noticing a rumbling sound), ran out a nearby exterior door, and called that he was "burning up." A second operator, some 40 feet away in an adjoining room, saw a reflection of the light on the walls ("like a photo-flash"), heard the report, went to help, and was joined by a third operator. Returning to lead the first man to a shower (on request, apparently as the result of suspecting an acid burn), they passed the tank, and the second operator turned off the stirrer motor.

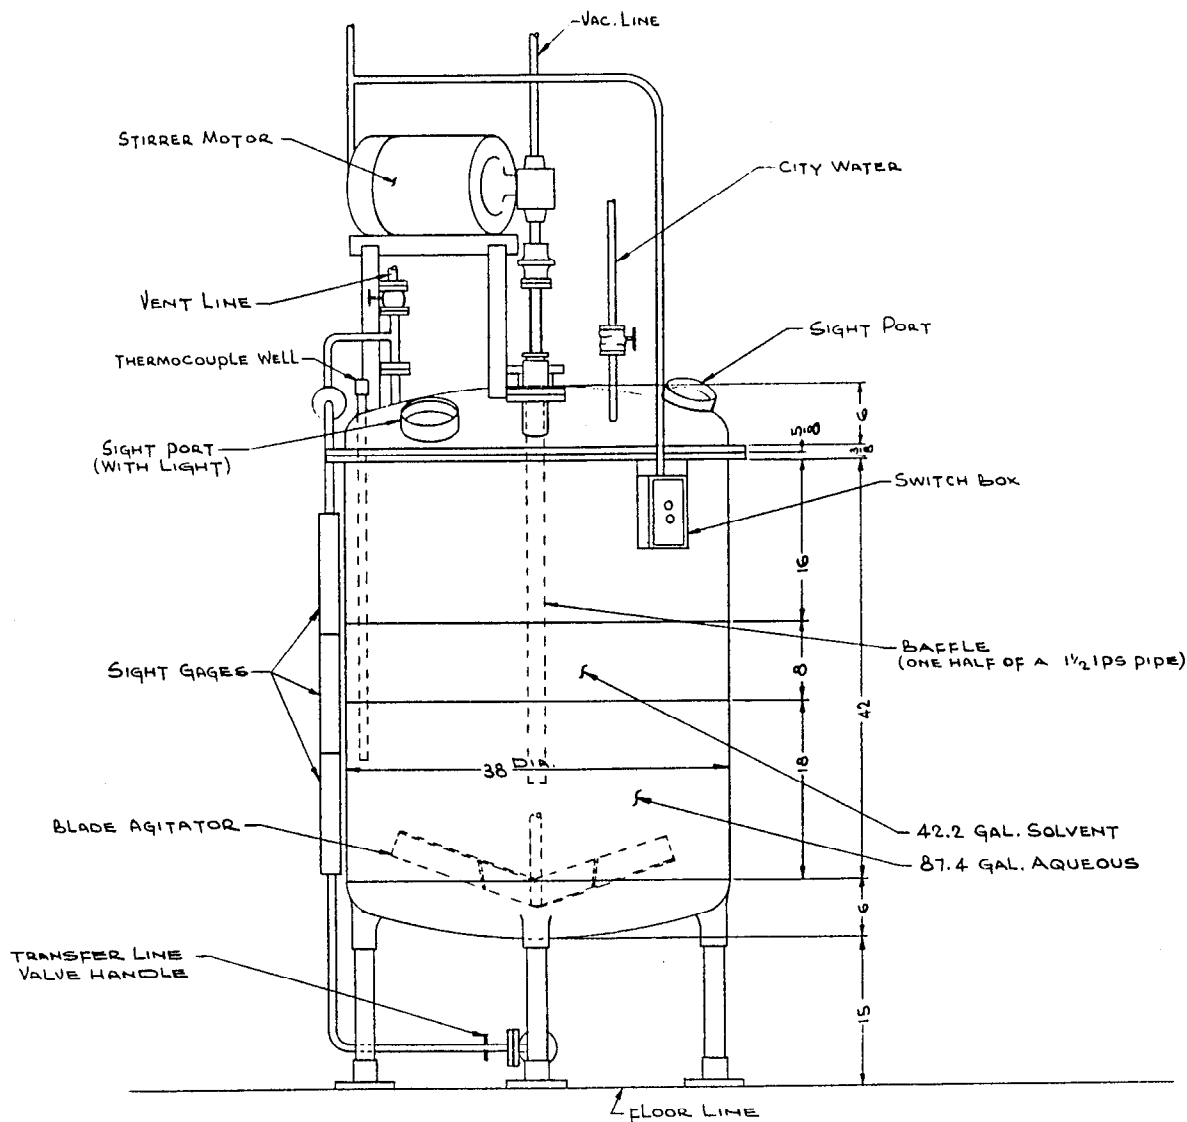
The situation in the 225-gallon, 38-in.-diameter, solvent-treating tank immediately before the accident is believed to be as illustrated in Fig. 12: 87.4 gallons of aqueous solution contained 40 g of Pu, and on top, a 42.2-gallon layer of solvent contained 3.27 kg of Pu. Solids (containing 60 g of Pu) were suspended in both the aqueous and organic phases and at the interface. Few solids settled to the bottom of the tank. Estimates based on Fig. 13, taking into account the tank diameter and effects of neutron "poisons," indicate that the 8-in.-thick solvent layer was barely subcritical at the plutonium concentration of 20 g/liter (the estimated critical thickness is 8-1/4 inches, and the actual configuration was roughly 5 dollars subcritical).

Fig. 12 Diagram of solvent-treating tank, showing levels of aqueous and organic phases before stirrer was activated.

The initial action of the stirrer in the solvent-treating tank forced aqueous solution up along the wall, displacing the outer portion of the solvent layer and thickening the central portion. An average increase in solvent-layer thickness of about 0.4 inch, corresponding to an average radius decrease of 1/2 inch, could account for the obviously supercritical configuration. The burst was certainly terminated by the violent disturbance that it generated, and continuation of the stirring diluted the plutonium beyond the point at which a critical reaction could recur.

Additional evidence that the plutonium was concentrated in the solvent layer when the burst occurred is given by the long-lived gamma activity of the stainless steel baffle (type-347) that was located about 6 inches within the wall of the solvent-treating tank (Fig. 12). Scanning indicated a peak in activity about 1 inch below the mid-plane of the solvent layer.

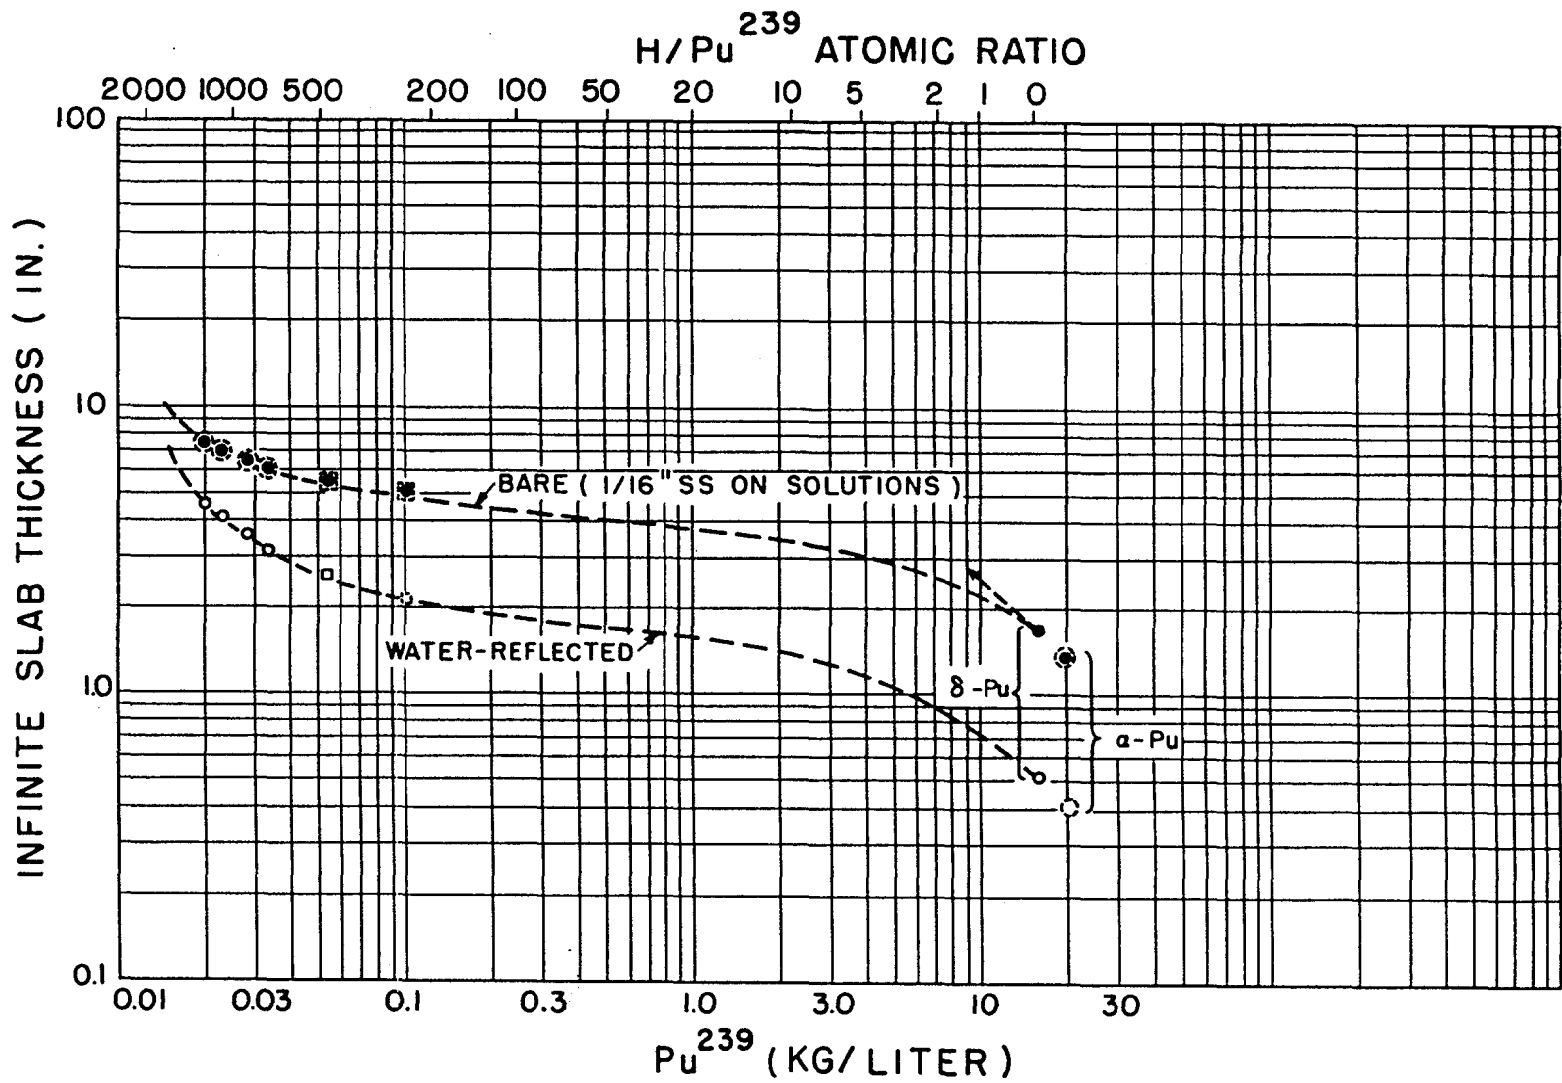
Fig. 13 Estimated critical thicknesses of infinite slabs of homogeneous water-moderated Pu^{239} in the absence of NO_3 and Pu^{240} . Based on data from F. E. Kruesi, J. O. Erkman, and D. D. Lanning, Hanford Report HW-24514, May 1952 (classified).

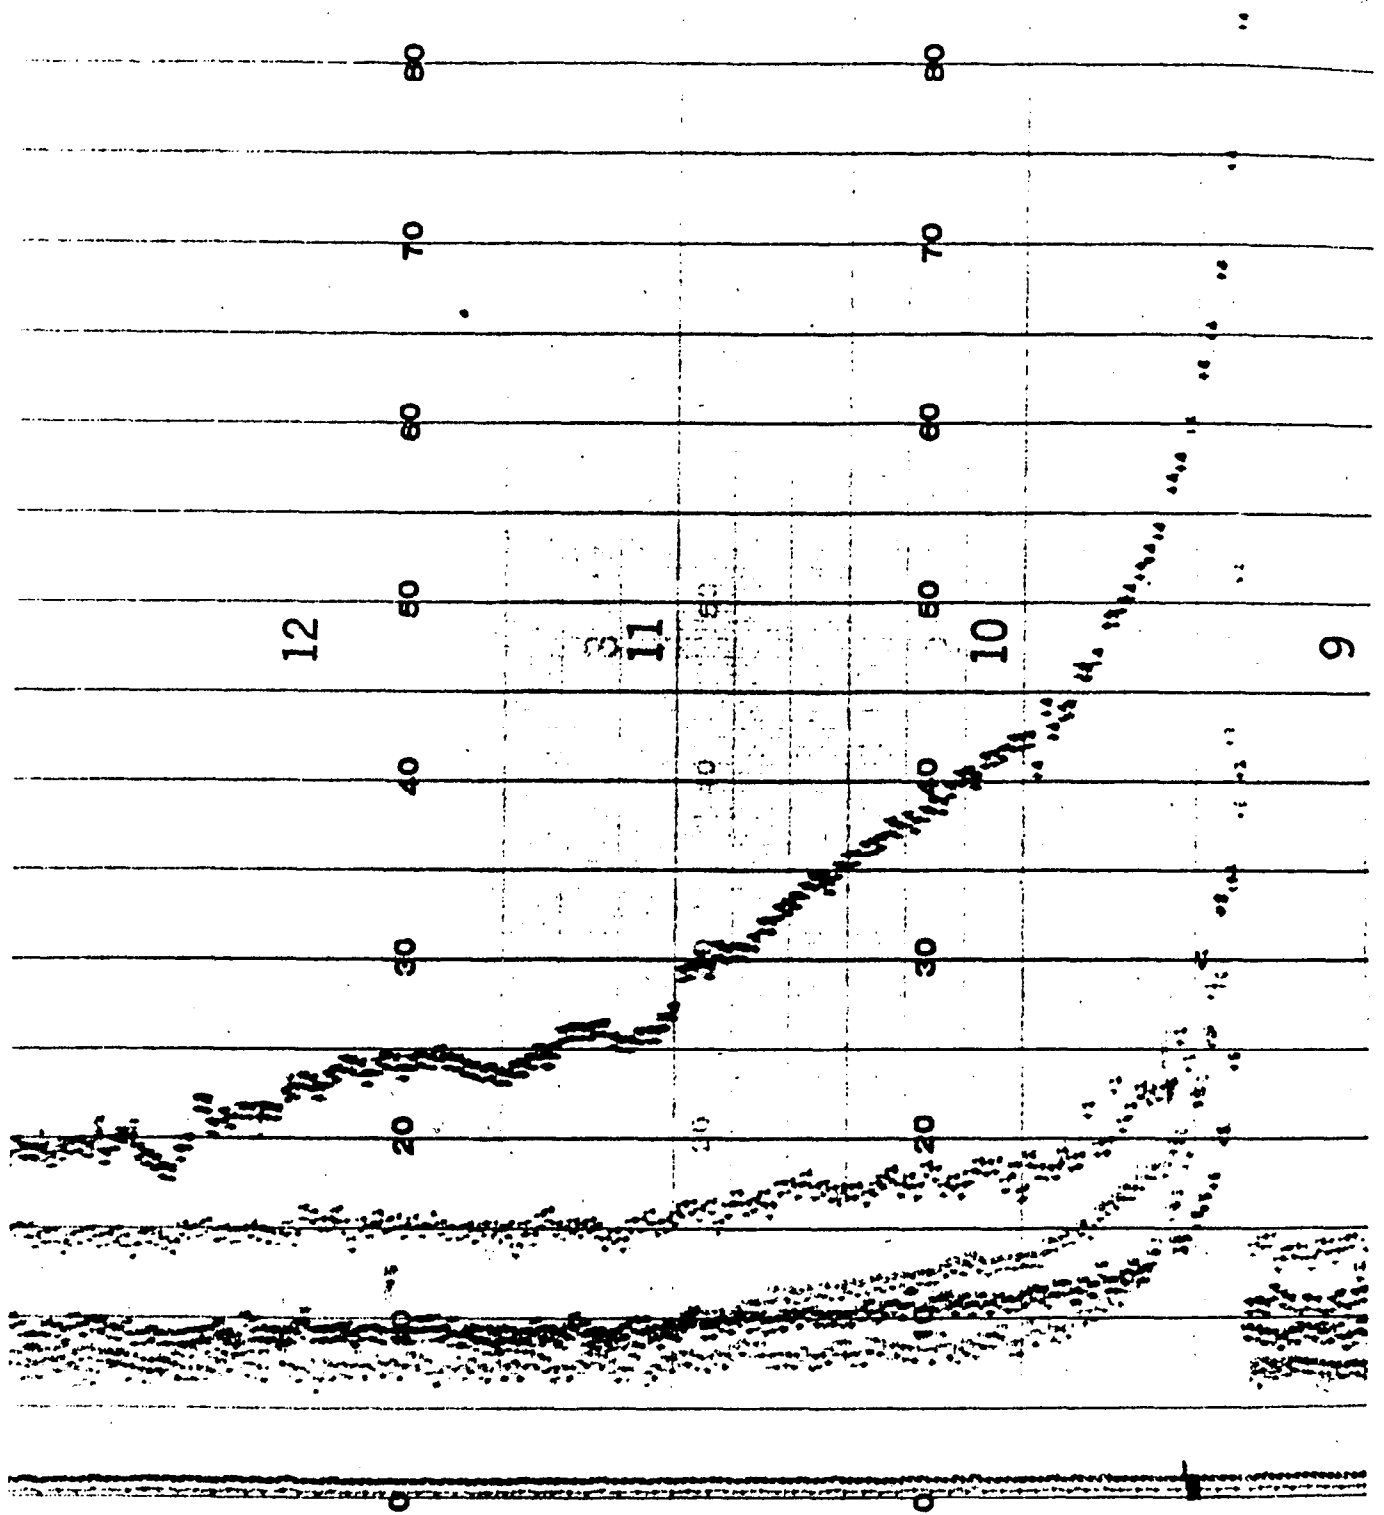
None of the gamma-sensitive recording detectors within range of the accident showed an ideal trace. They suggest, however, that there was but a single burst -- see, for example, the record reproduced in Fig. 14.

Radiochemical analyses for Mo⁹⁹ (concentrated mostly in the aqueous phase) indicate that the total number of fissions in the burst was about 1.5×10^{17} . This value may be subject to refinement when analyses for other fission products are complete.

Fig. 14 Trace of slow-acting recorder (Point No. 4) located 160 ft from tank.

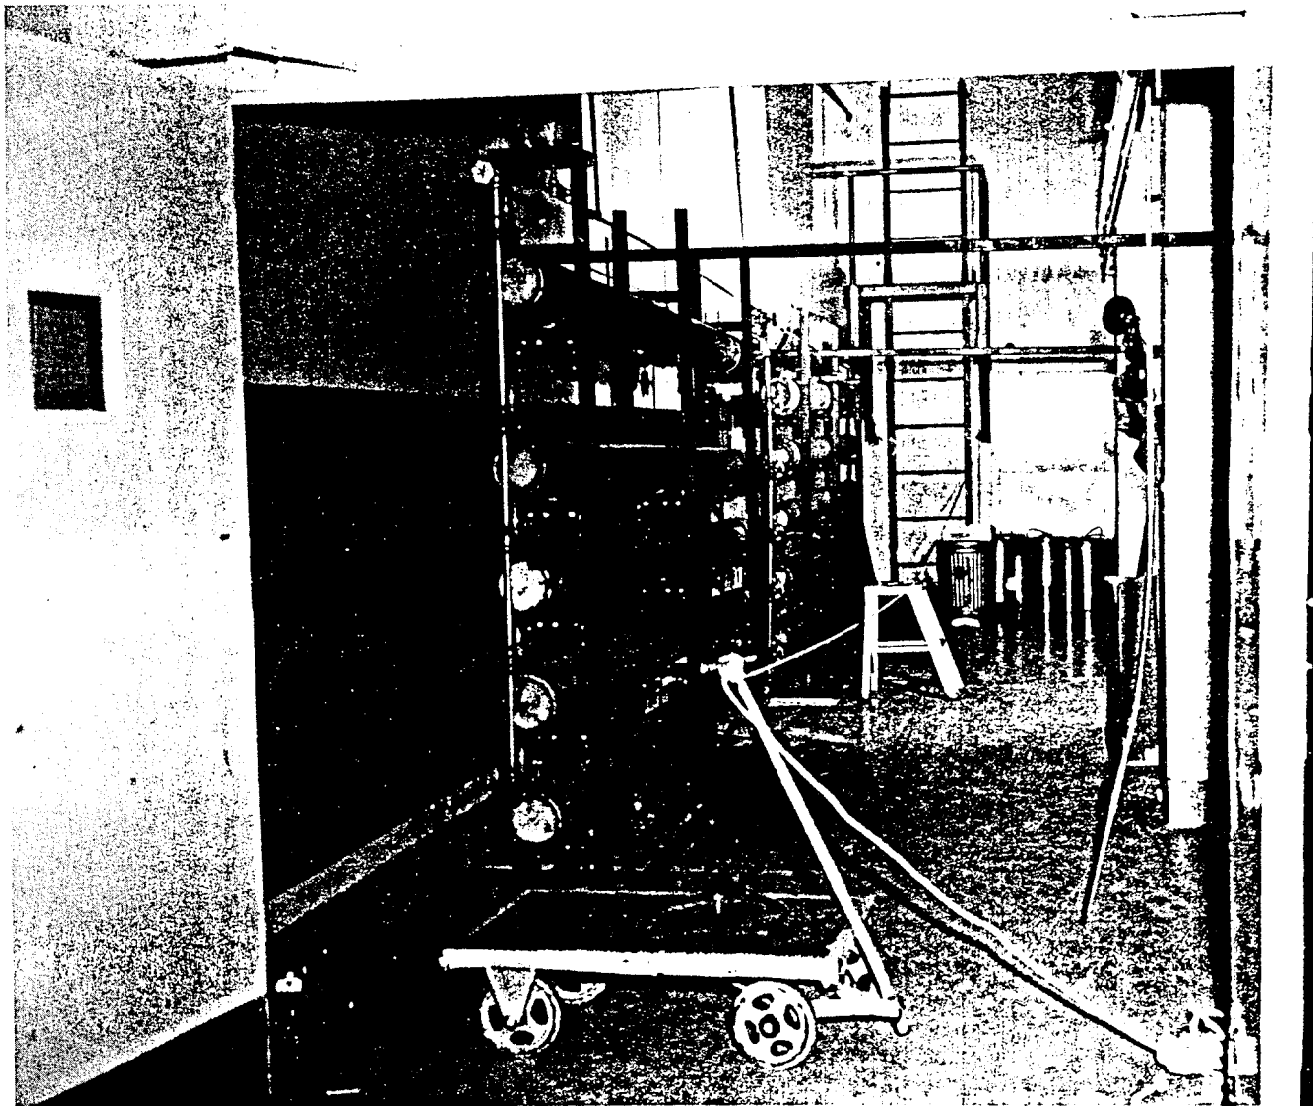
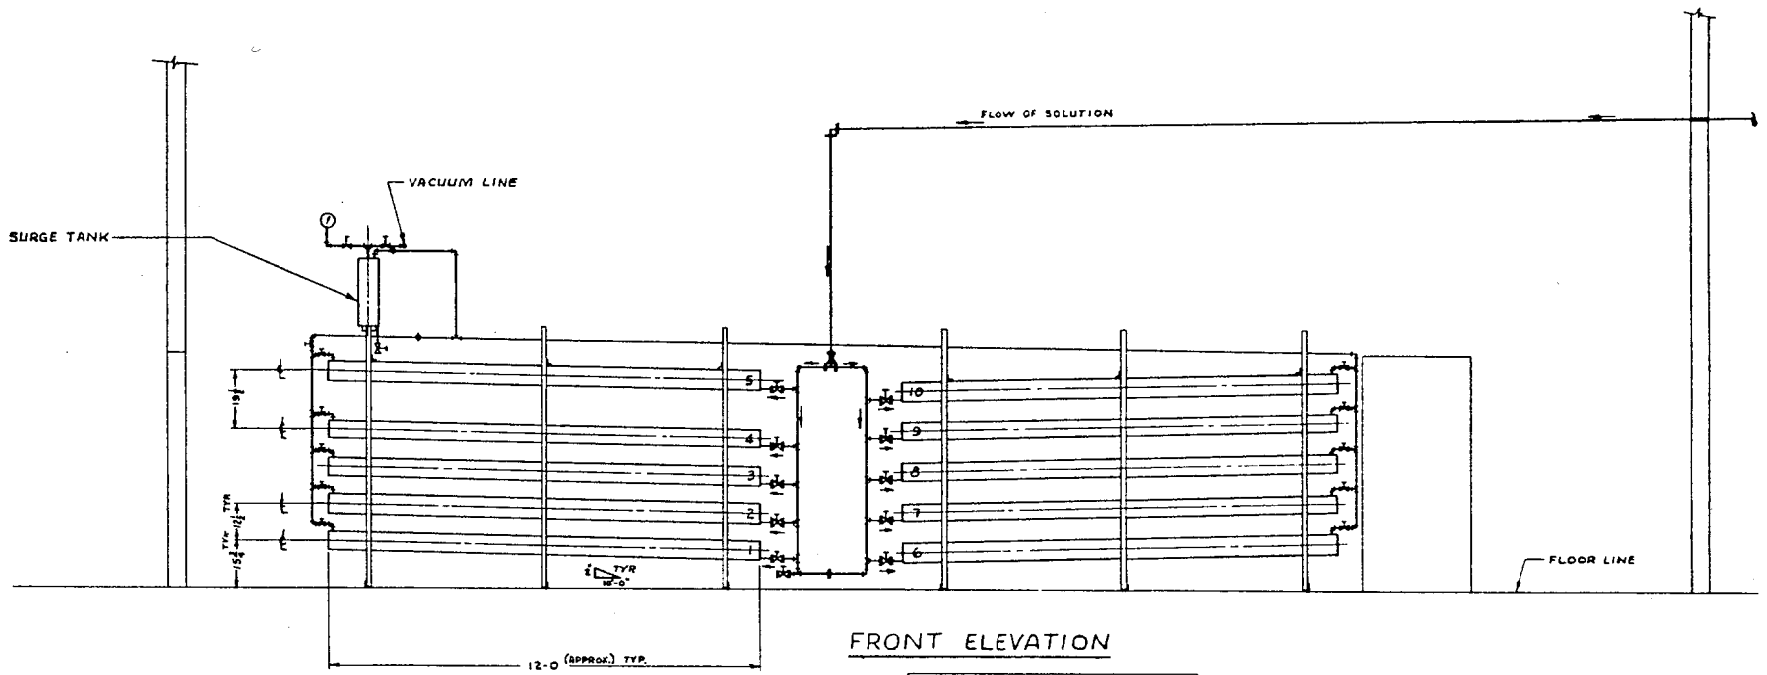
Immediately after the incident, a bank of ten 6- and 5-in.-diameter cylinders was fabricated and set up about 100 feet from the point of the accident (see Figs. 3, 15, and 16). This storage array was connected to a transfer line that leads from the bottom outlet of the solvent-treating tank. As the disposition of plutonium in the tank was then unknown, opening of the bottom outlet valve was a suspect operation and was therefore accomplished from behind a temporary shield by means of a 10-foot extension handle. The solution was vacuum-transferred into the bank of cylinders without complication on January 1, 1959. The solution level within the cylinders was followed by gamma-sensing instruments. Maximum reading at contact was about 1 r/hr, and indications along the wall of the solvent-treating tank immediately after emptying were less than 50 mr/hr.

Successive 9-liter lots of solution were removed from the storage cylinders, and each batch was sampled for chemical analysis. Results of analysis are summarized in Table 3. Not only was the bulk of the plutonium found to be in the organic solvent phase, but a concentration of Zr^{95} in a suspension at the aqueous-organic interface suggested that the situation was the same at the time of the accident. Furthermore, the chemical form in which the plutonium occurred in the solvent was consistent with the hypothesis that it had been complexed with TBP hydrolysis products.

Fig. 15 Geometrically-favorable tanks used to receive the solution.

Fig. 16 Schematic diagram of geometrically-favorable storage cylinders.
