ATOMIC ENERGY OF CANADA LIMITED

AN INVESTIGATION OF SOME OF THE CIRCUMSTANCES
PERTINENT TO THE ACCIDENT TO THE NRX REACTOR
OF DECEMBER 12, 1952

W.J. HENDERSON, A.C. JOHNSON, AND P.R. TUNNICLIFFE

MARCH 31, 1953

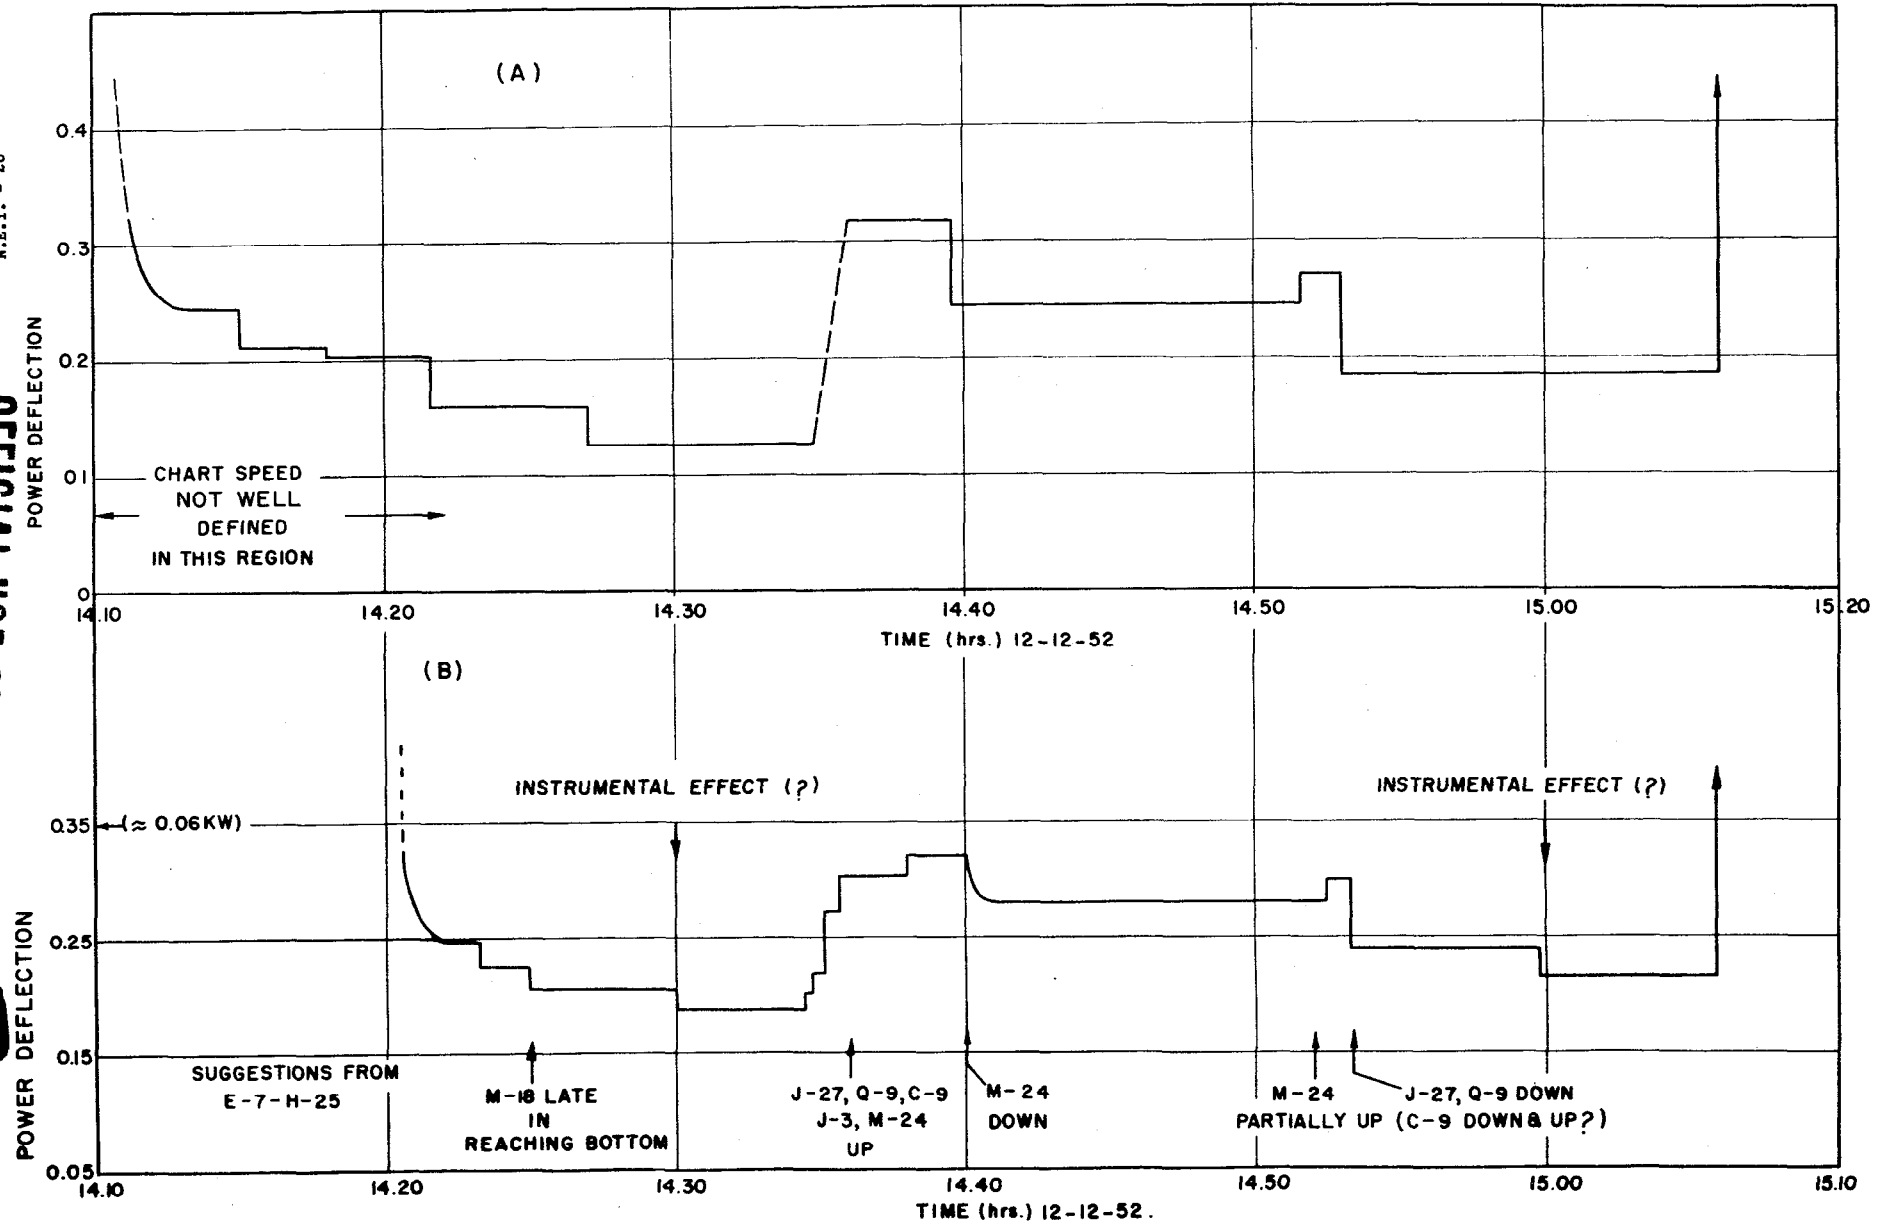
FIG. 1.

The section of these records covering the interval following the shut-down from the preceding critical height measurements up to the accident is reproduced in figure 1. These reproductions represent analyses of the records using a travelling microscope. Since the pen deflections of the recorders only amounted to a few millimetres, they should be regarded with some reserve, particularly since the zero corrections are uncertain. However, essentially all the changes in the power level can be accounted for, from the information given by E-7-H-25, by shut-off rods rising and falling. It is to be pointed out that the magnitude of the changes are not necessarily the same for each record. This can be attributed to distortions in the flux distribution by the rods.

There is no reason to believe that the low point of these records at 14.30 hours did not represent a condition of the reactor similar to that at 05.57 hours and almost certainly (see Appendix) one in which all the shut-off rods and the control rod were down. Consequently, it is evident that all the rods were not down immediately before 15.07 hours.

ENLARGEMENT OF (A) SOUTH & (B) NORTH THERMAL COLUMN ION CHAMBER RECORDINGS.

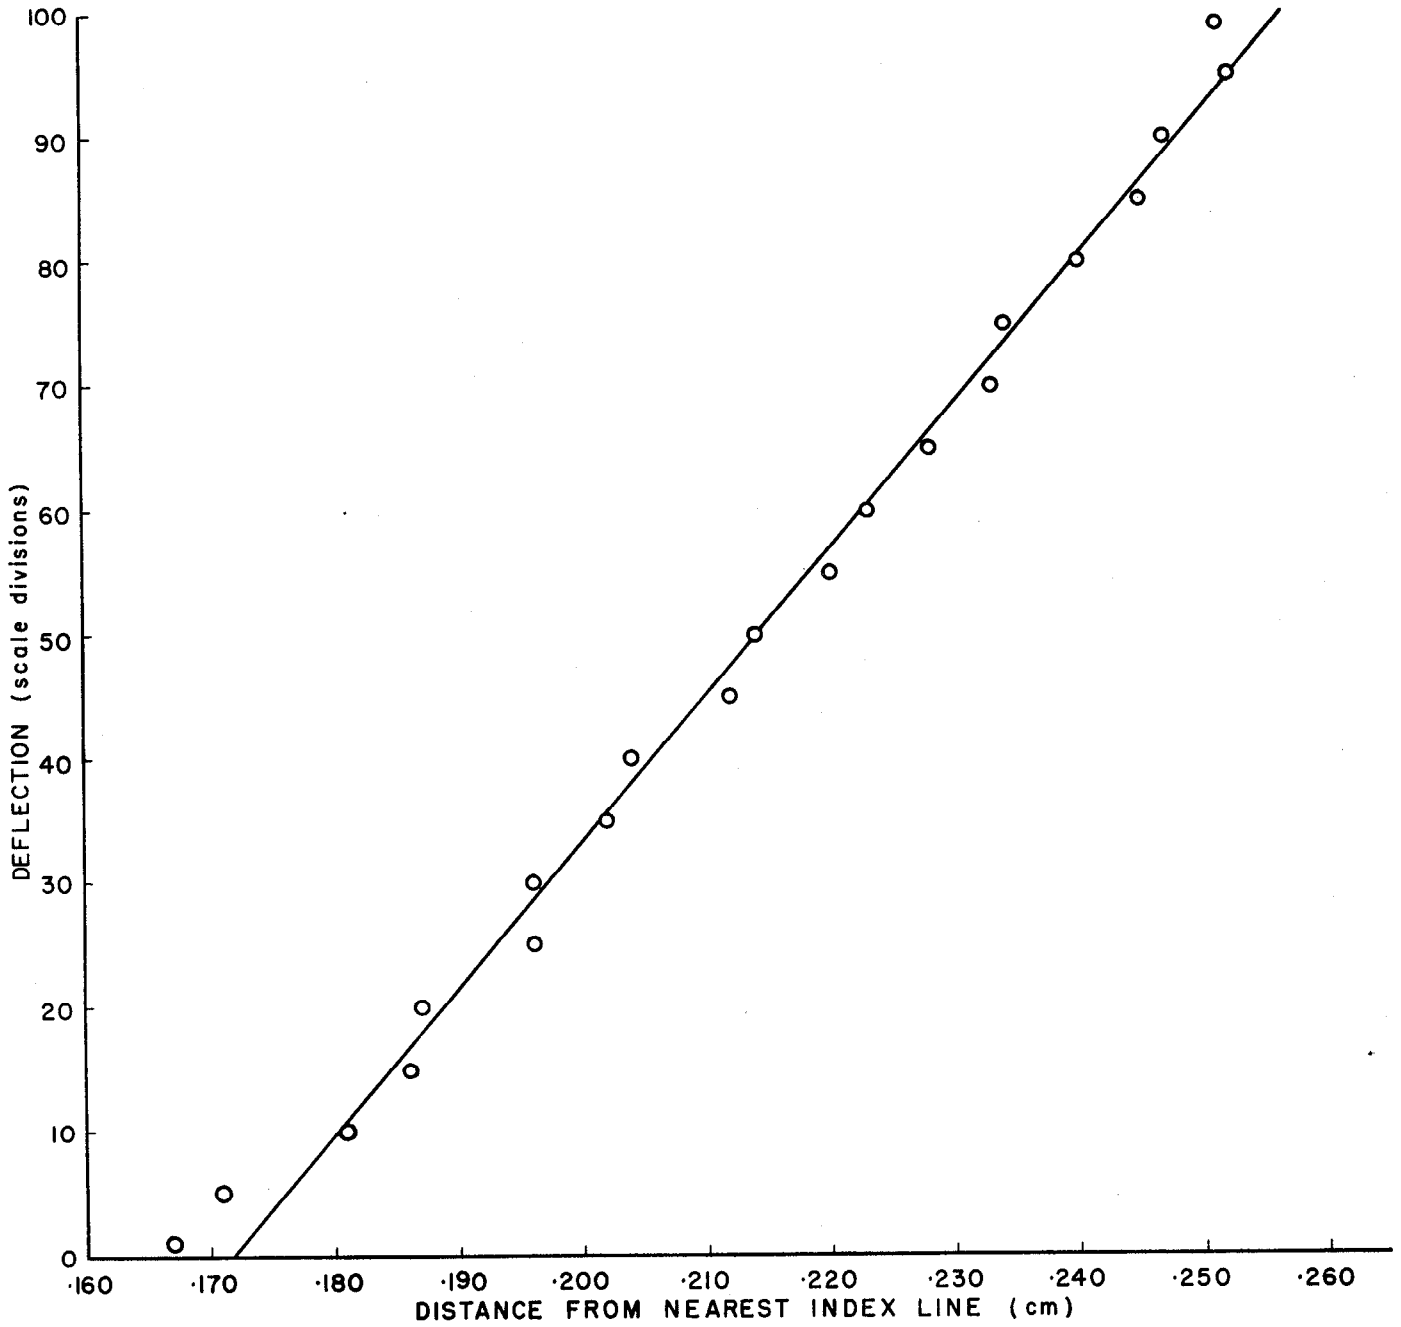
FIG. 2 NORTH THERMAL COLUMN. ANALYSIS OF RECORD

The north thermal column recorder was taken for further investigation. The analysis described above is presented in figure 2. The actual D.C. amplifier and recorder used were removed from the control room and set up alongside the electronic pile analogue. The output power indication from the analogue is in the form of a voltage up to a maximum of 200 volts. This was converted to an effective infinite impedance constant current source simulating an ion chamber by feeding the voltage to the D.C. amplifier input through a $2 \times 10^8 \Omega$ resistor. The impedance conditions were satisfied on the range used during the power transient since the input impedance was $5 \times 10^8 \Omega$ / gain of feedback = $5 \times 10^5 \Omega$. The input was loaded with 3000 pf, the estimated capacity load in the pile installation. In this way it was hoped that all time constant effects were reproduced.

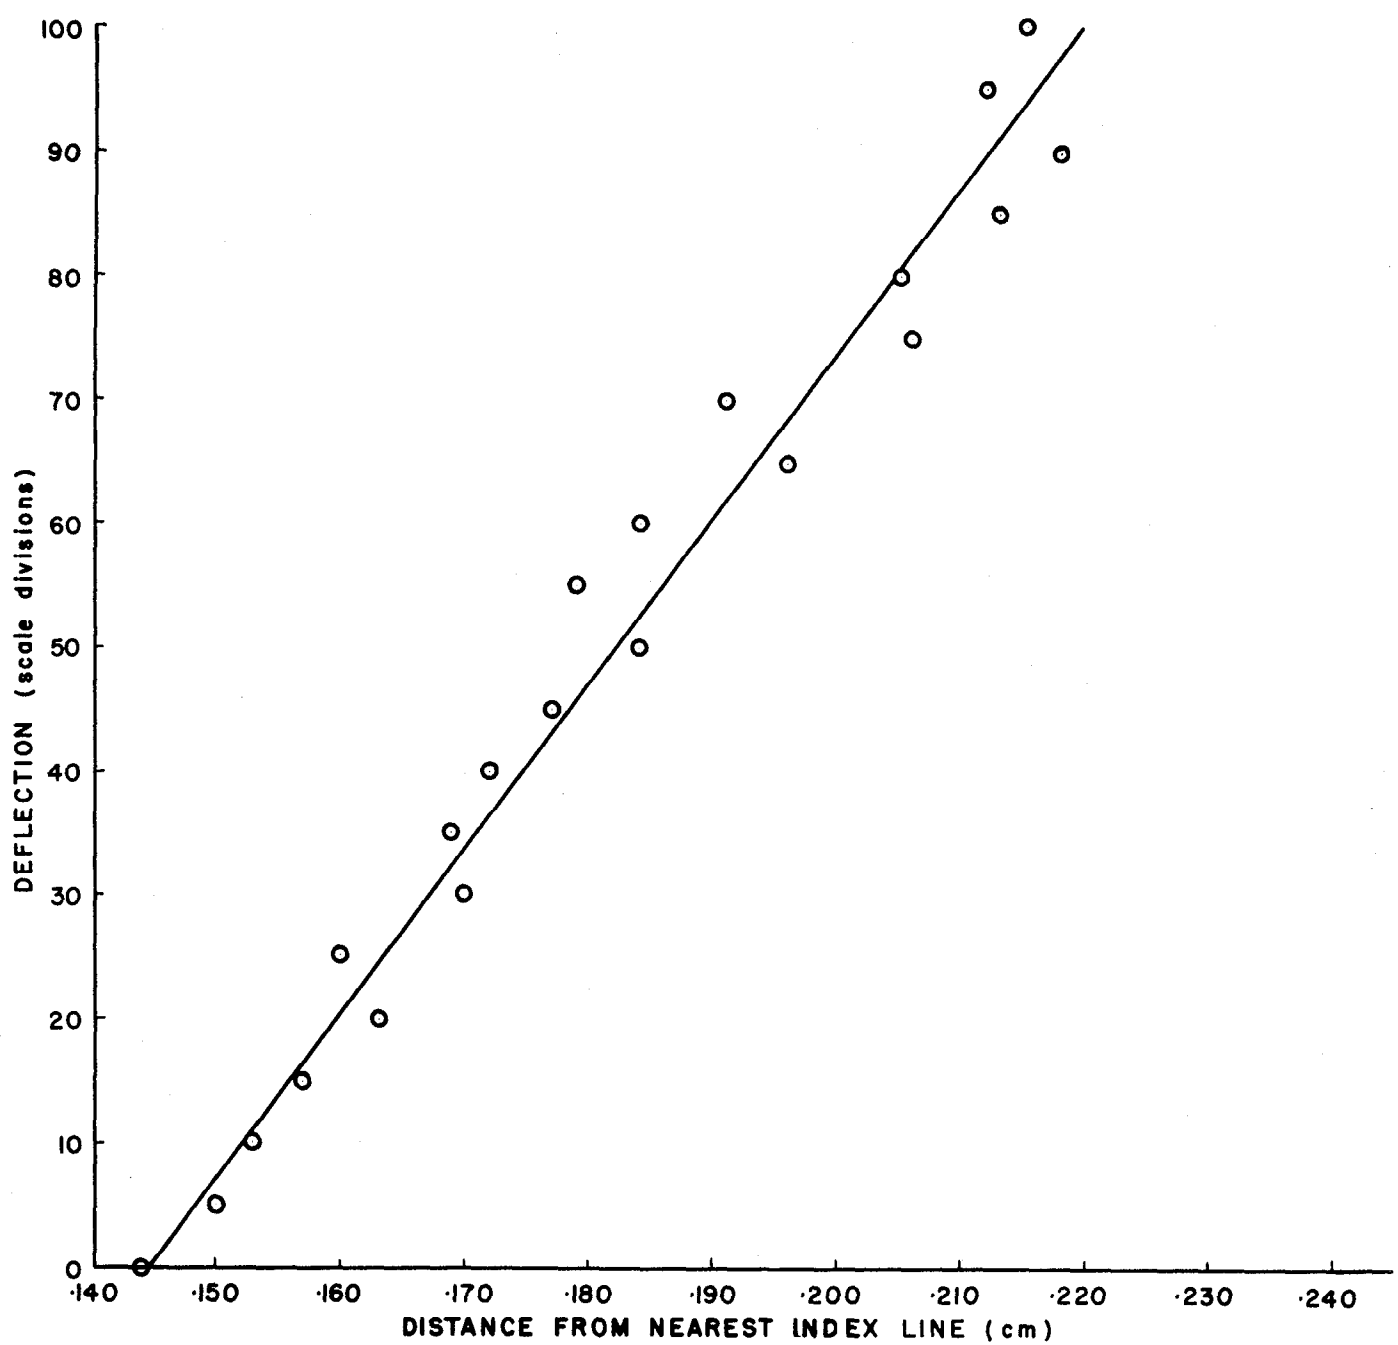
FIG. 3 BROWN RECORDER AND DC AMPLIFIER. EFFECT OF OVERLOAD SIGNAL

In the first instance a number of power transients were simulated by suddenly unbalancing the D.C. amplifier, thus presenting the recorder with a gross overload signal. The transit time of the pen was found to be 20.4 seconds consistently. The traces obtained were analysed by the method described and plotted in the same manner as figure 1. Each analysis gave essentially a straight line but the transit time deduced varied from 22.8 to 37.2 seconds as compared with the directly measured time of 20.4 seconds. A typical analysis giving a transit time of 26.5 seconds is shown in figure 3. It is believed that this spread of deduced times originated from lack of perpendicularity and variation of the angle between the time and deflection axes of the recorder within the scale of measurements. This is not surprising.

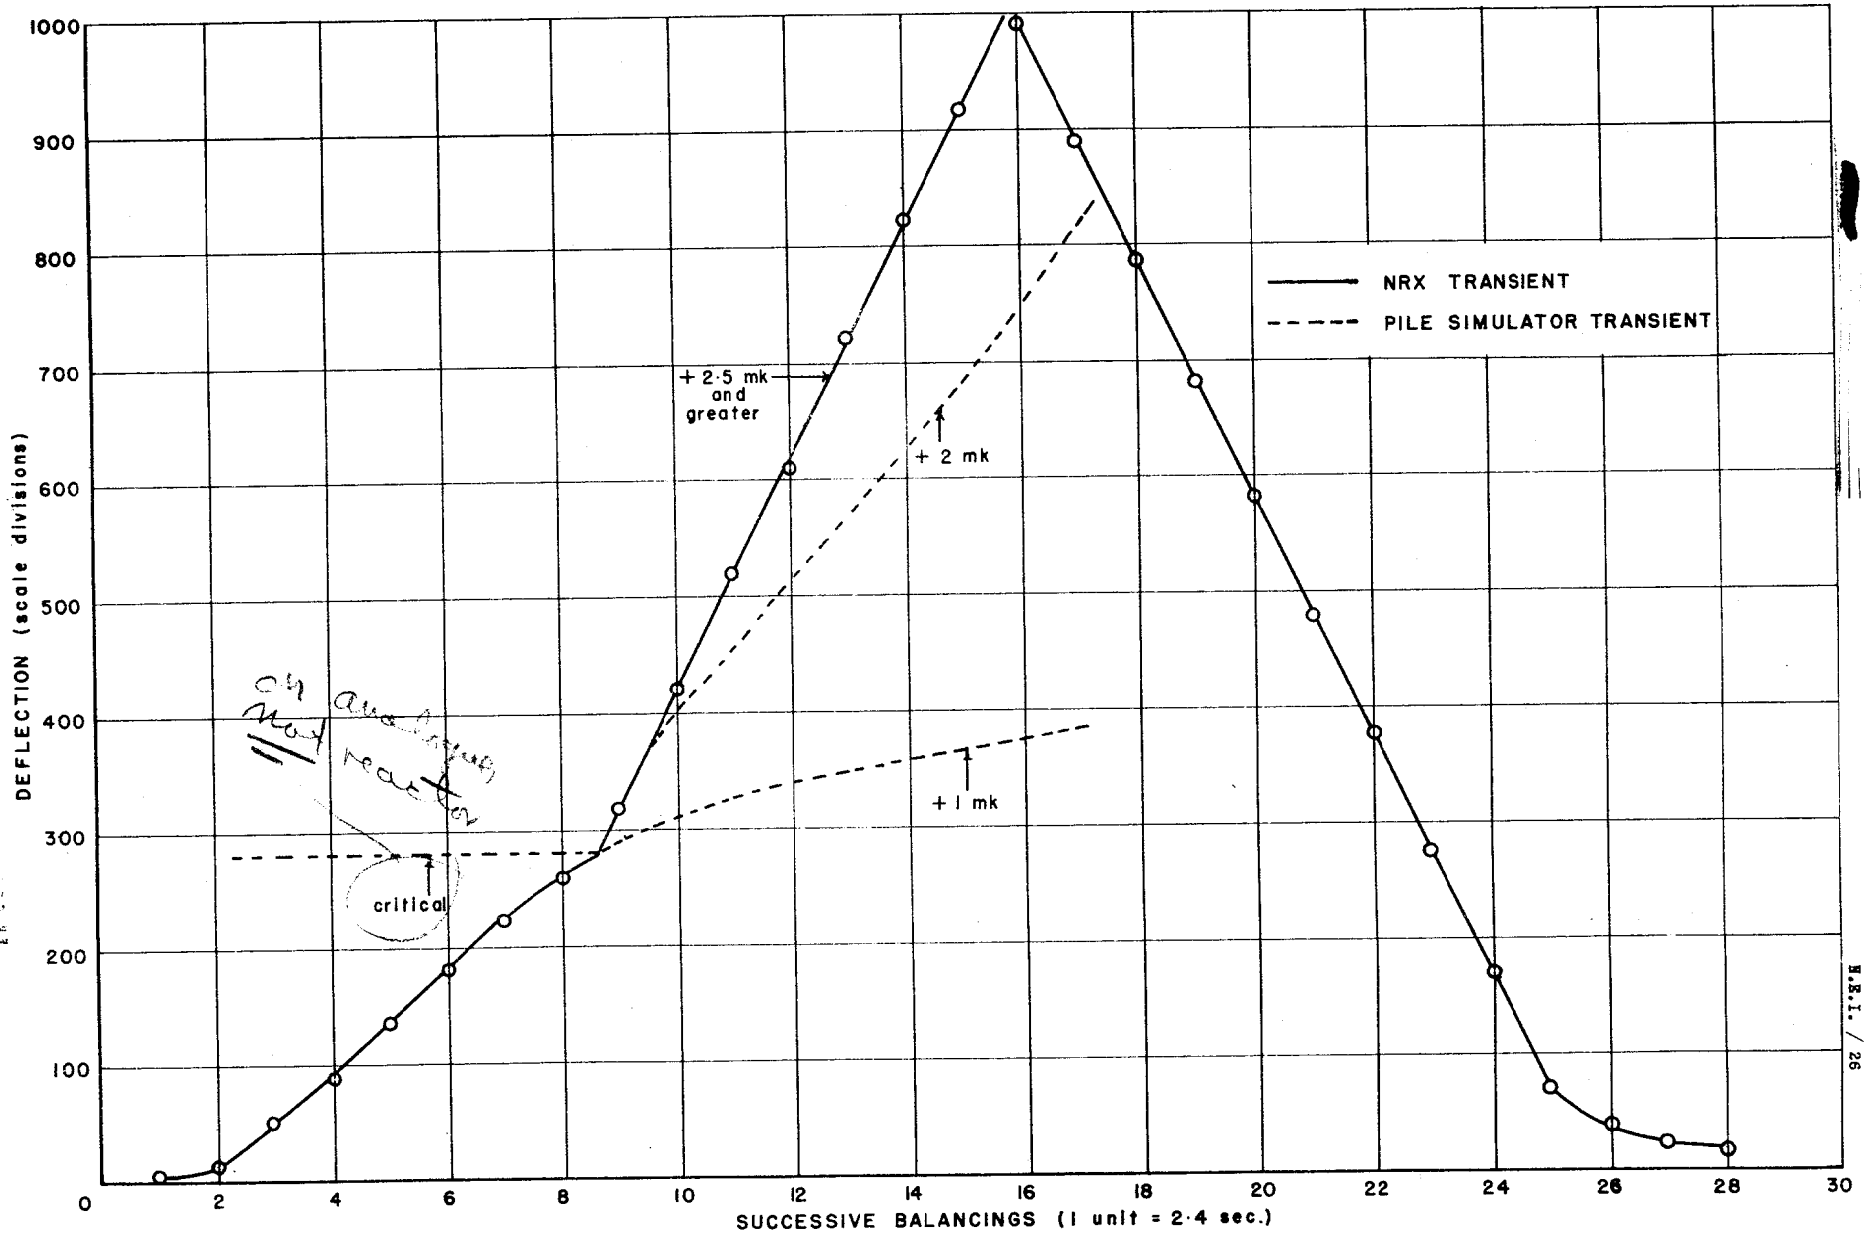
FIG. 6 E-7-L-109A ANALYSIS OF RECORD. POSITIONS OF RECORDER PEN ON SUCCESSIVE BALANCINGS

The record of the power transient consisted of a barely inked broken line and an attempt to analyse it by the method given above proved unsatisfactory indicating an excessive tilt of the instrument axes compared with the width of the transient. However, examination of the trace showed that the stationary positions of the pen during successive attempts made by the instrument servo-mechanism, to achieve balance, could be readily distinguished. Since the time intervals between successive balance attempts is well defined a very good plot could be made of instrument reading against time. This is shown in figure 6.

It should be noted that the pile power exceeded "1 MW" (109A) for less than sixty-two seconds.

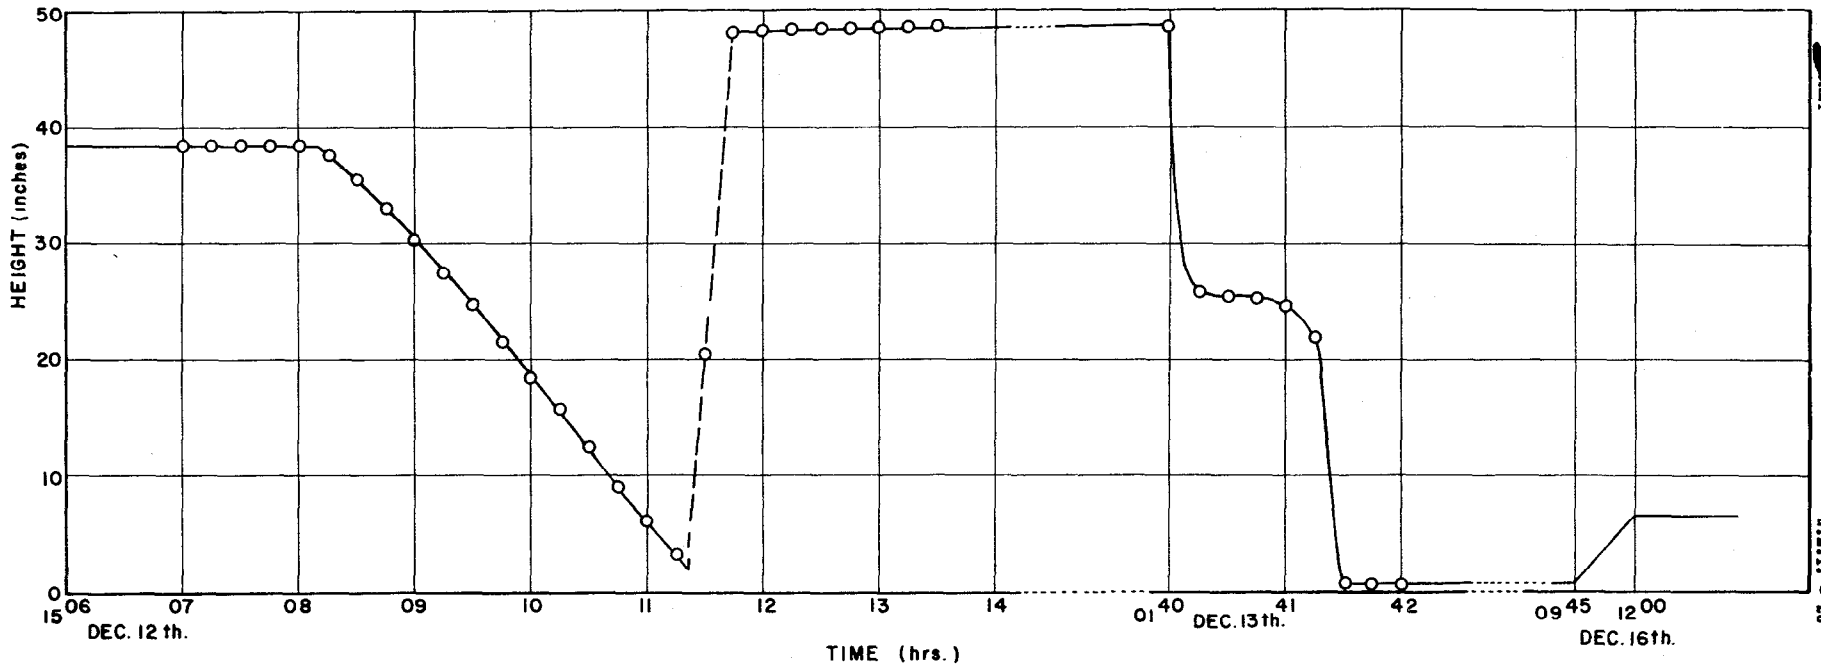
FIG. 7.

The initial rate of fall of the gasholder occurring at 15.08 hours is not inconsistent with the appearance of a large hole in the calandria. A leak rate of 140 cu.ft./min. indicated by the rate of fall does not appear to be inconsistent with the flow rate possible at 12 ins. pressure through the helium lines connecting the gasholder to the calandria ^{*}.

The following rapid rise of the gasholder in less than 30 seconds, implies an incoming flow of 920 cu.ft./min., or 5720 I.G.P.M., which flow rates cannot be explained by any effect associated with dumping the polymer (maximum rate 330 g.p.m.) or leakage of light water into the system. (The maximum flow normally delivered to the pile is 3300 g.p.m. There was no indication of a large increase in this). A pressure of the order of 5 lbs/sq.in. ^{*} appearing in the calandria could explain the rate of rise, provided the pressure was maintained during the delivery of 460 cu.ft. of gas. The rapid burning of about 70 Kgm. of uranium under water could produce the required amount in the form of hydrogen. Although the continued burning of hot uranium under water is possible due to the large evolution of heat (2.6 megajoules/Kgm) the consumption of such a large amount seems unlikely.

GASHOLDER HEIGHT

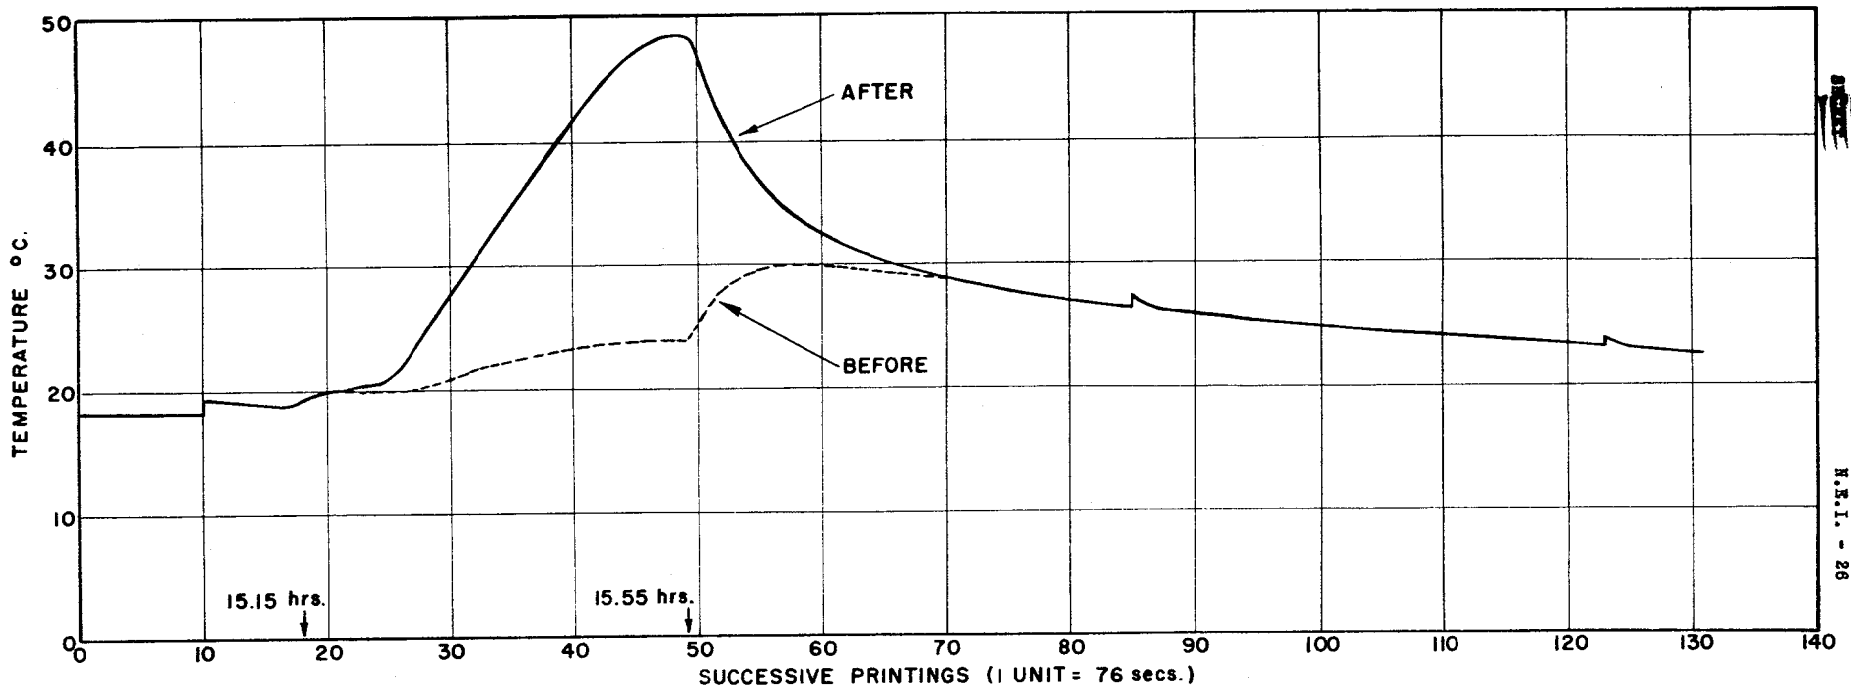
FIG. 8.

the accident is shown in figure 8. The times noted are taken from the chart. The sharp pips occurring about once per hour are associated with the standardizing procedure of the recorder.

TEMPERATURES BEFORE AND AFTER THE CATALYST.
