LAMS-2293

NUCLEAR-CRITICAL ACCIDENT AT THE LOS ALAMOS
SCIENTIFIC LABORATORY ON DECEMBER 30, 1958

REPORT WRITTEN: February 1959

H. C. Paxton
R. D. Baker
W. J. Maraman
Roy Reider

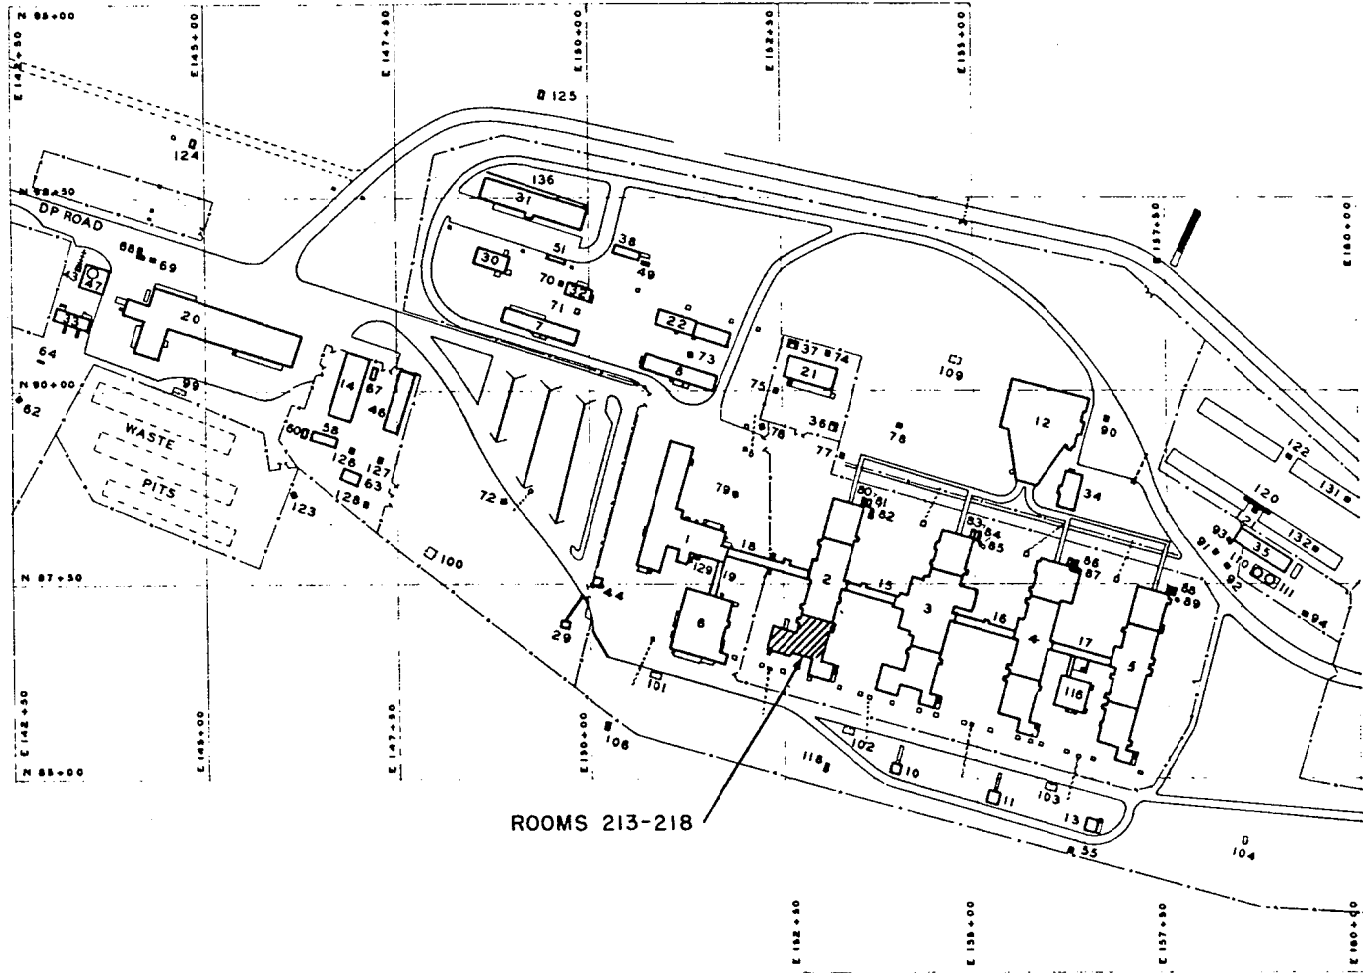
The layout of the site at which the accident occurred and the specific area involved (Rooms 213-218) are shown in Fig. 1. The part of the plutonium recovery operation involved in the accident was the tri-n-butyl phosphate (TBP) solvent-extraction process used to concentrate and purify plutonium from so-called "lean" residues, typically, solutions containing less than 0.1 g/liter of plutonium and traces of americium. A simplified flowsheet for the process is given in Fig. 2, and Fig. 3 shows the corresponding layout of equipment in the plant. Figures 4 to 9 delineate the steps involved in the procedures shown in Fig. 2.

Fig. 1 Map of DP Site. Shaded area indicates location of accident.

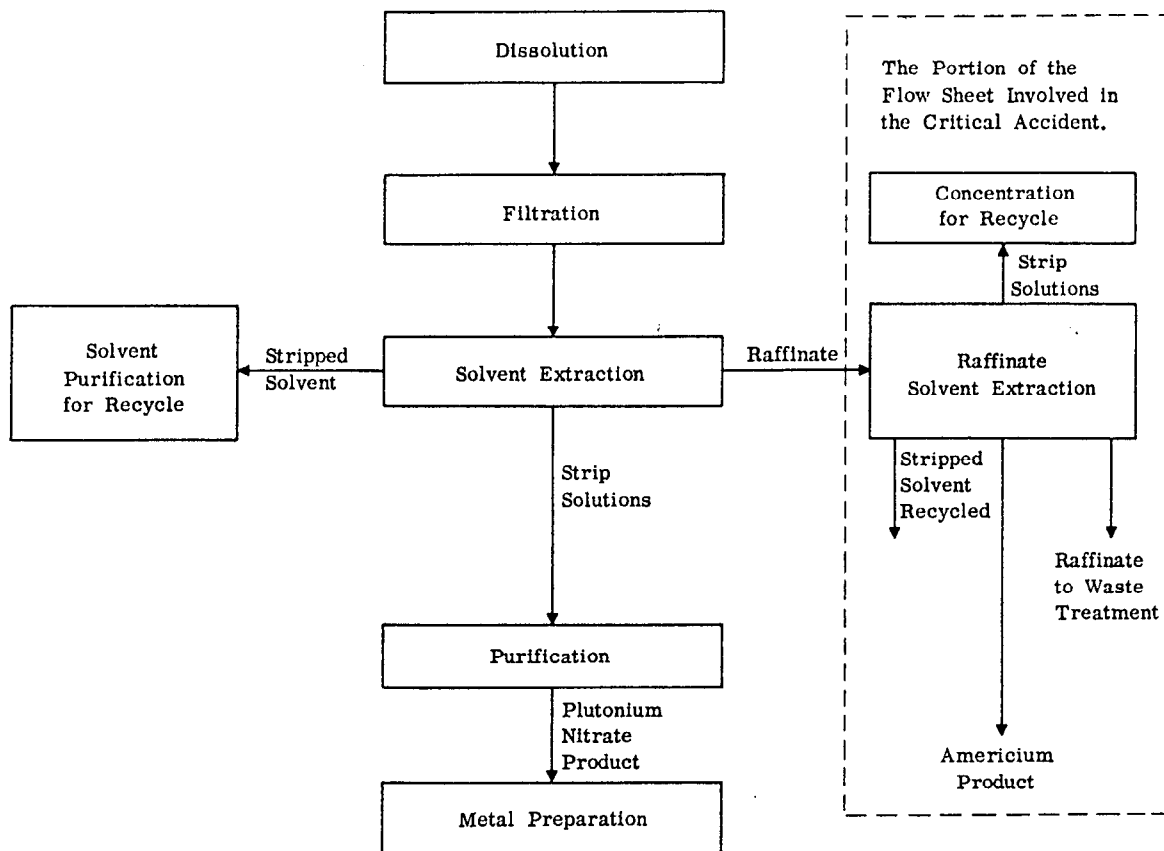
Fig. 2 Schematic flowsheet for the recovery of plutonium from lean residue.

associated with a hopefully-improved solvent-extraction process were planned to reduce dependence upon procedural control of batch sizes for nuclear-safety purposes, although this type of control had been used successfully during the 7-1/2 years that the plant was in operation. Installation of the new equipment was scheduled for June and July 1959. Depending upon the efficiency of the new extraction process, the possibility of eliminating the succeeding raffinate solvent-extraction and concentration stages (Fig. 2) was to be explored.
